Debris/Ice/TPS Assessment And Photographic Analysis For Shuttle Mission STS-37

April 1991

Gregory N. Katnik
NASA/Kennedy Space Center

DEBRIS/ICE/TPS ASSESSMENT
AND
PHOTOGRAPHIC ANALYSIS
OF
SHUTTLE MISSION STS-37

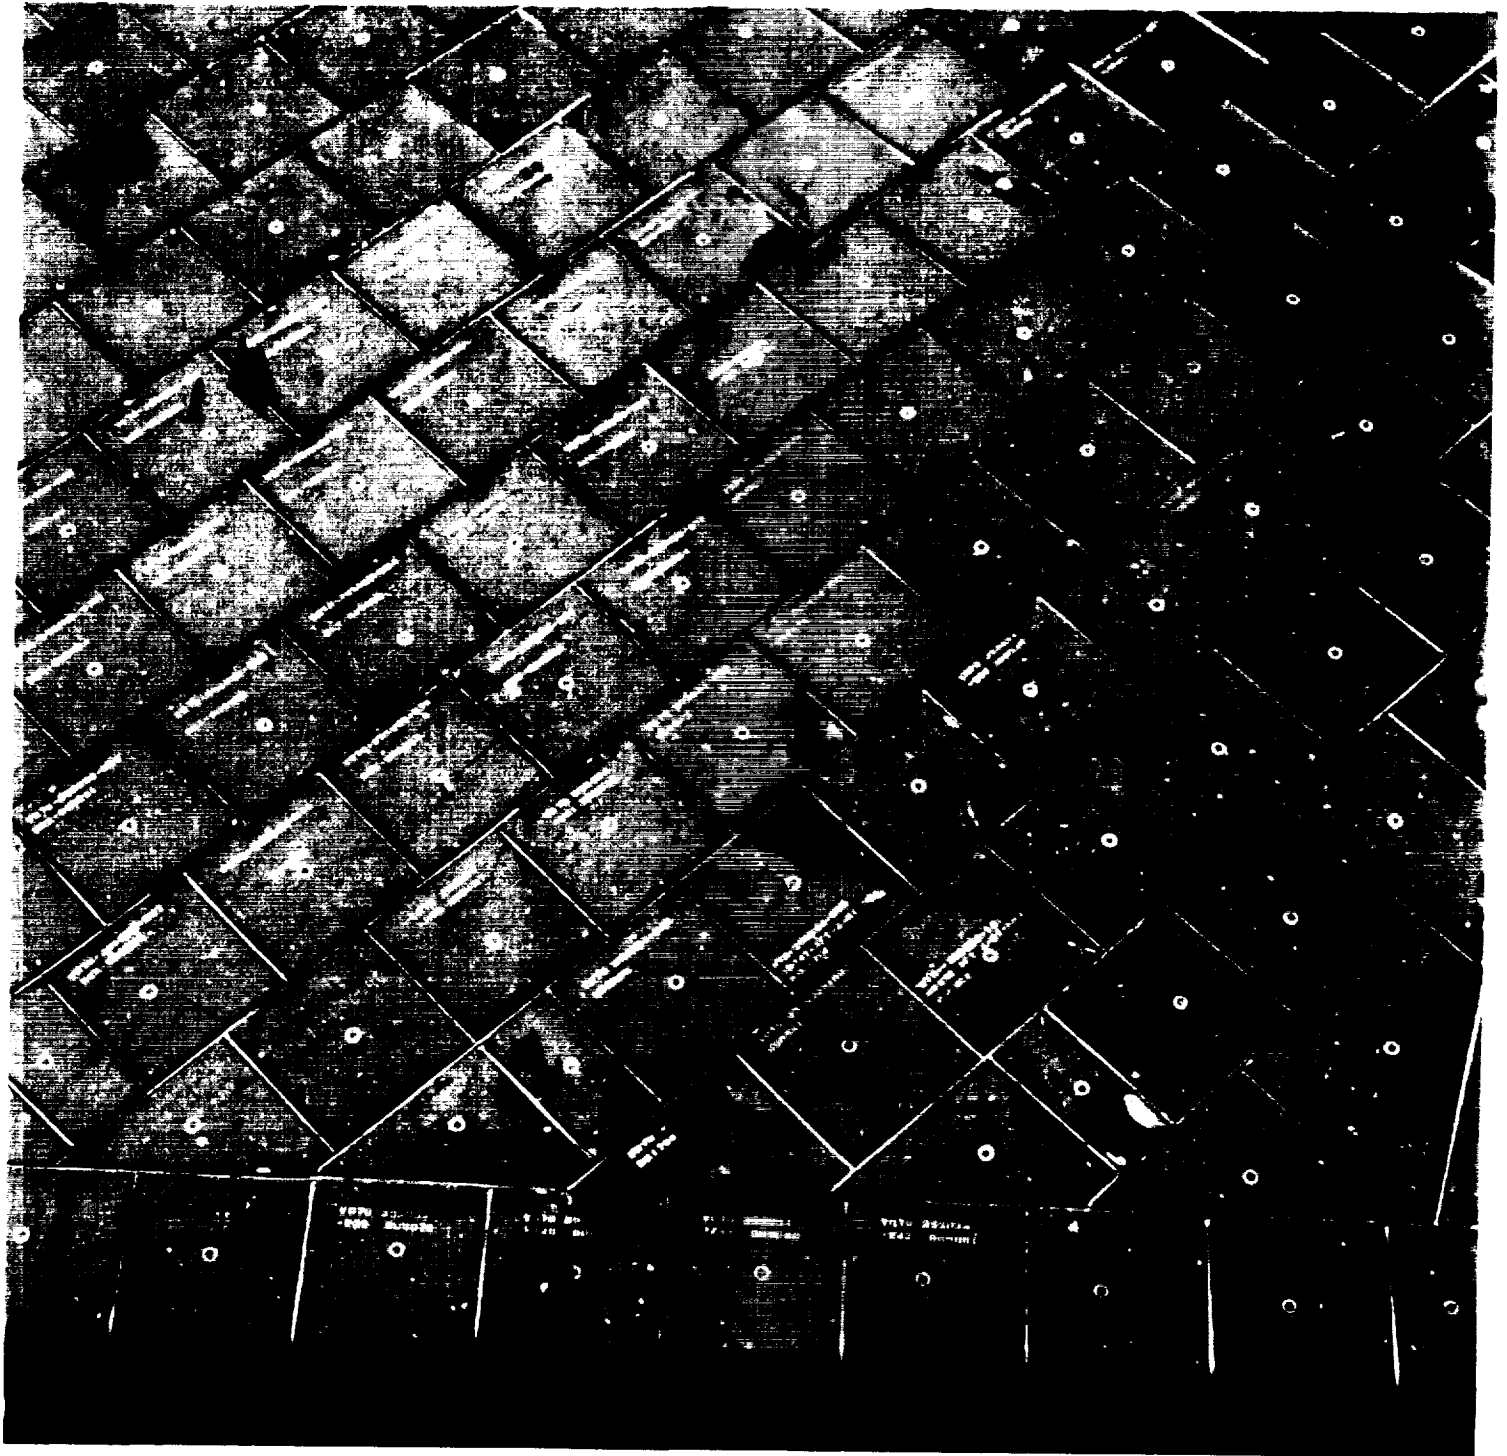
Foam, in the liquid state, dripped from the LH2 ET/ORB
umbilical onto body flap tiles during closeout operations

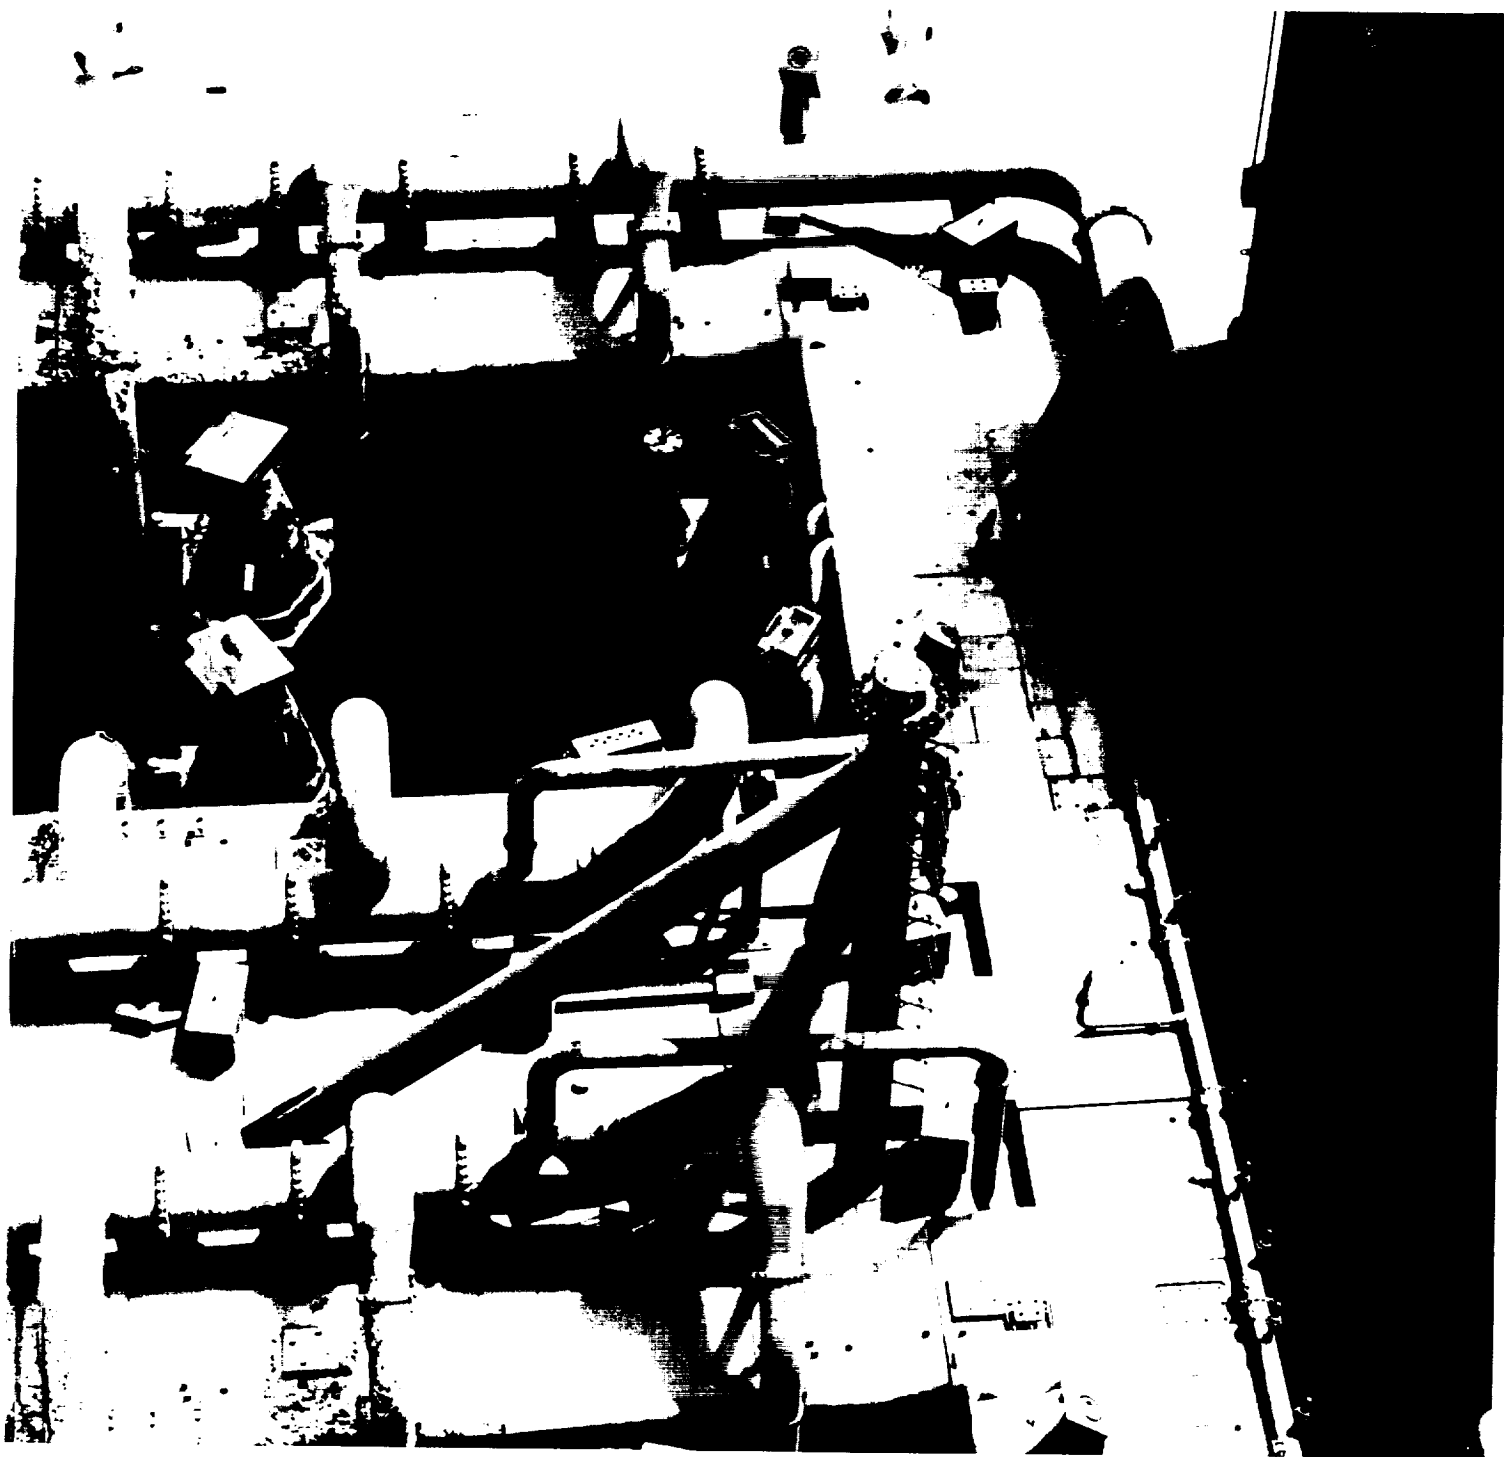
Post launch condition of MLP-1. The new hydrogen dispersal system sustained only minor damage from plume impingement.

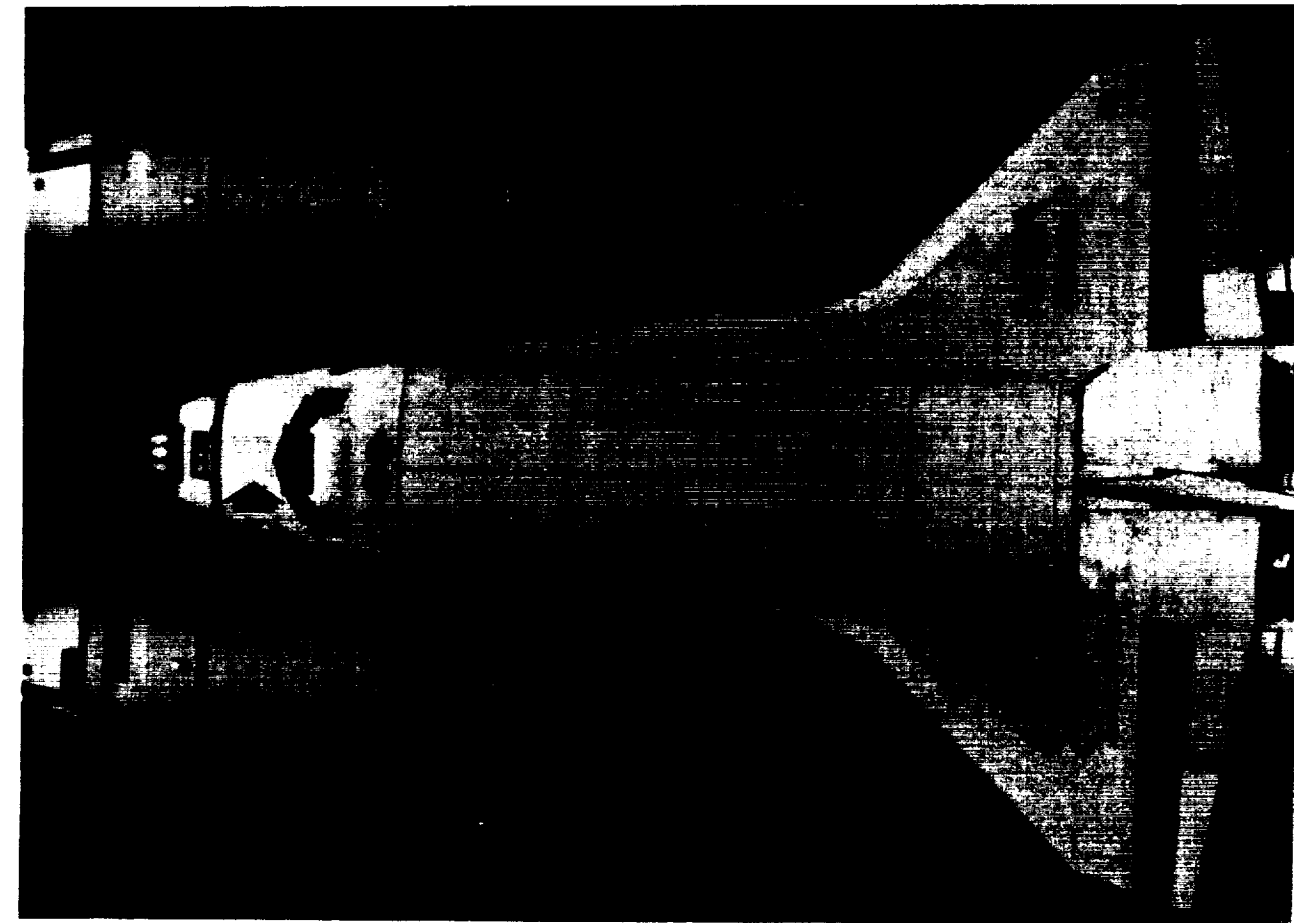
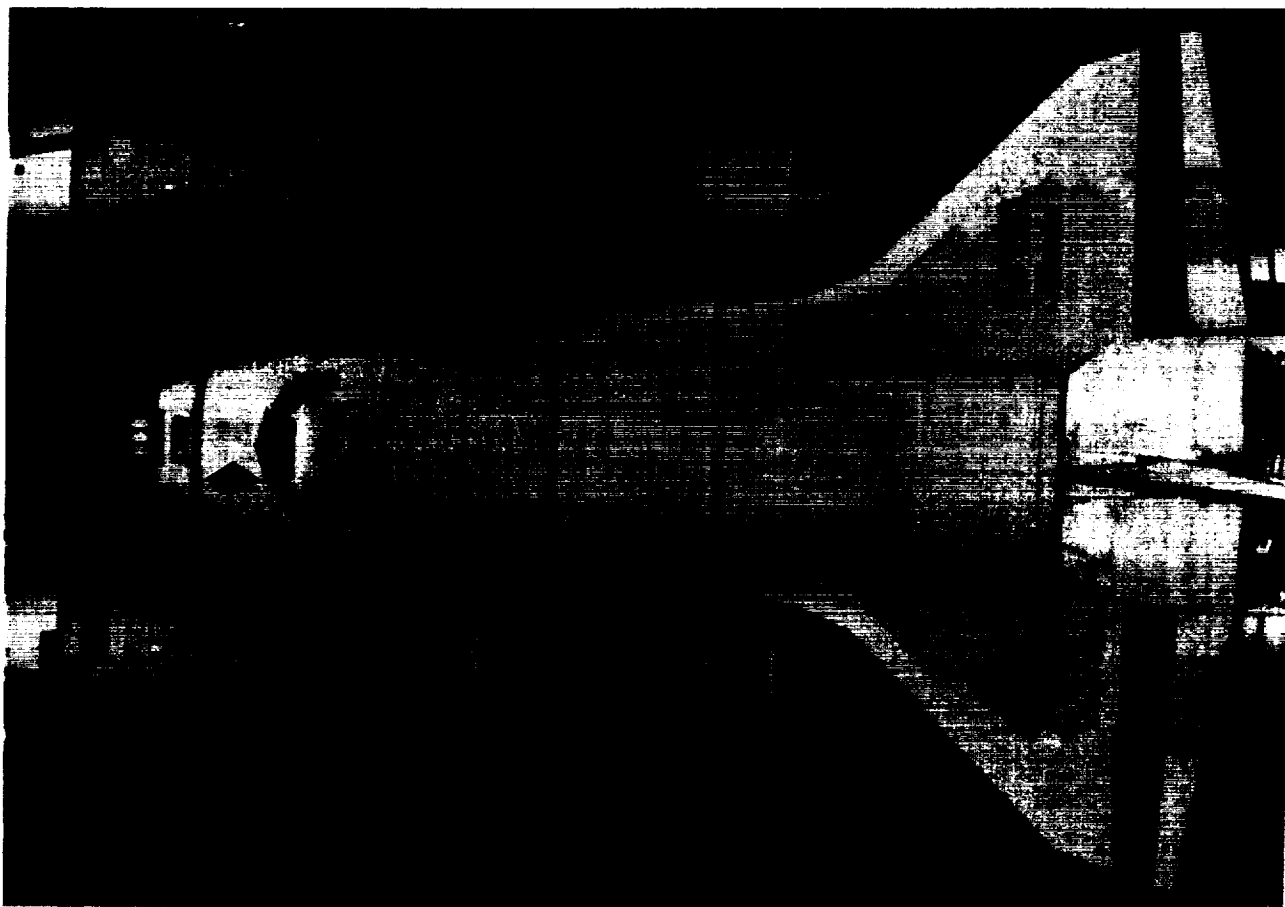
Just after initiation of the roll maneuver, the F2U FWD RCS paper cover detached from the thruster and released a puff of oxidizer vapor. This thruster had been leaking slightly during ground operations.

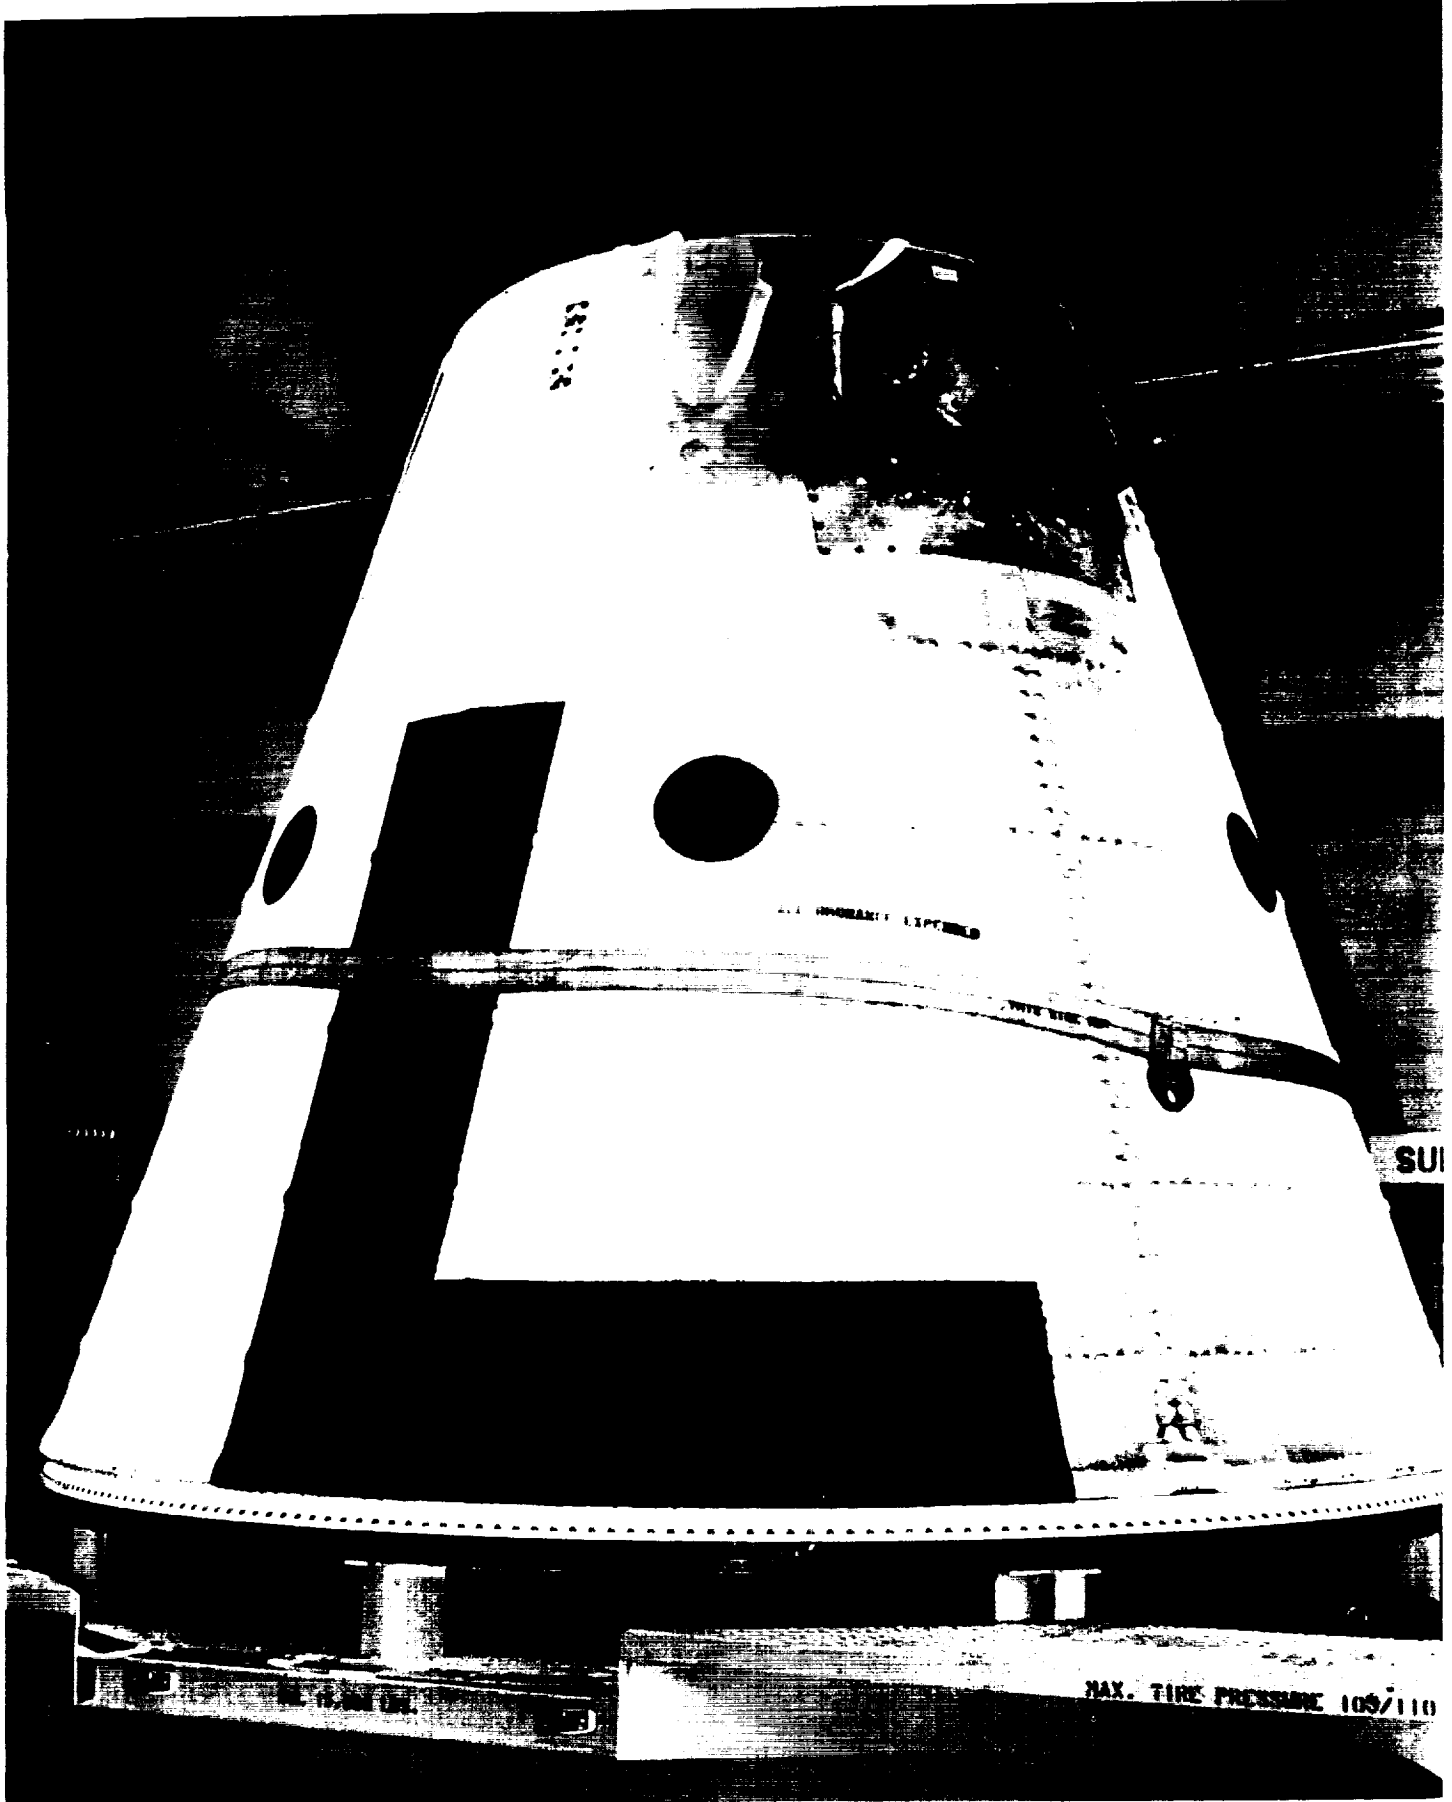
Post flight condition of the RH SRB frustum. There were 26 MSA-2 debonds over fasteners, but no missing material. BSM covers were bent by entanglement with the parachute risers.

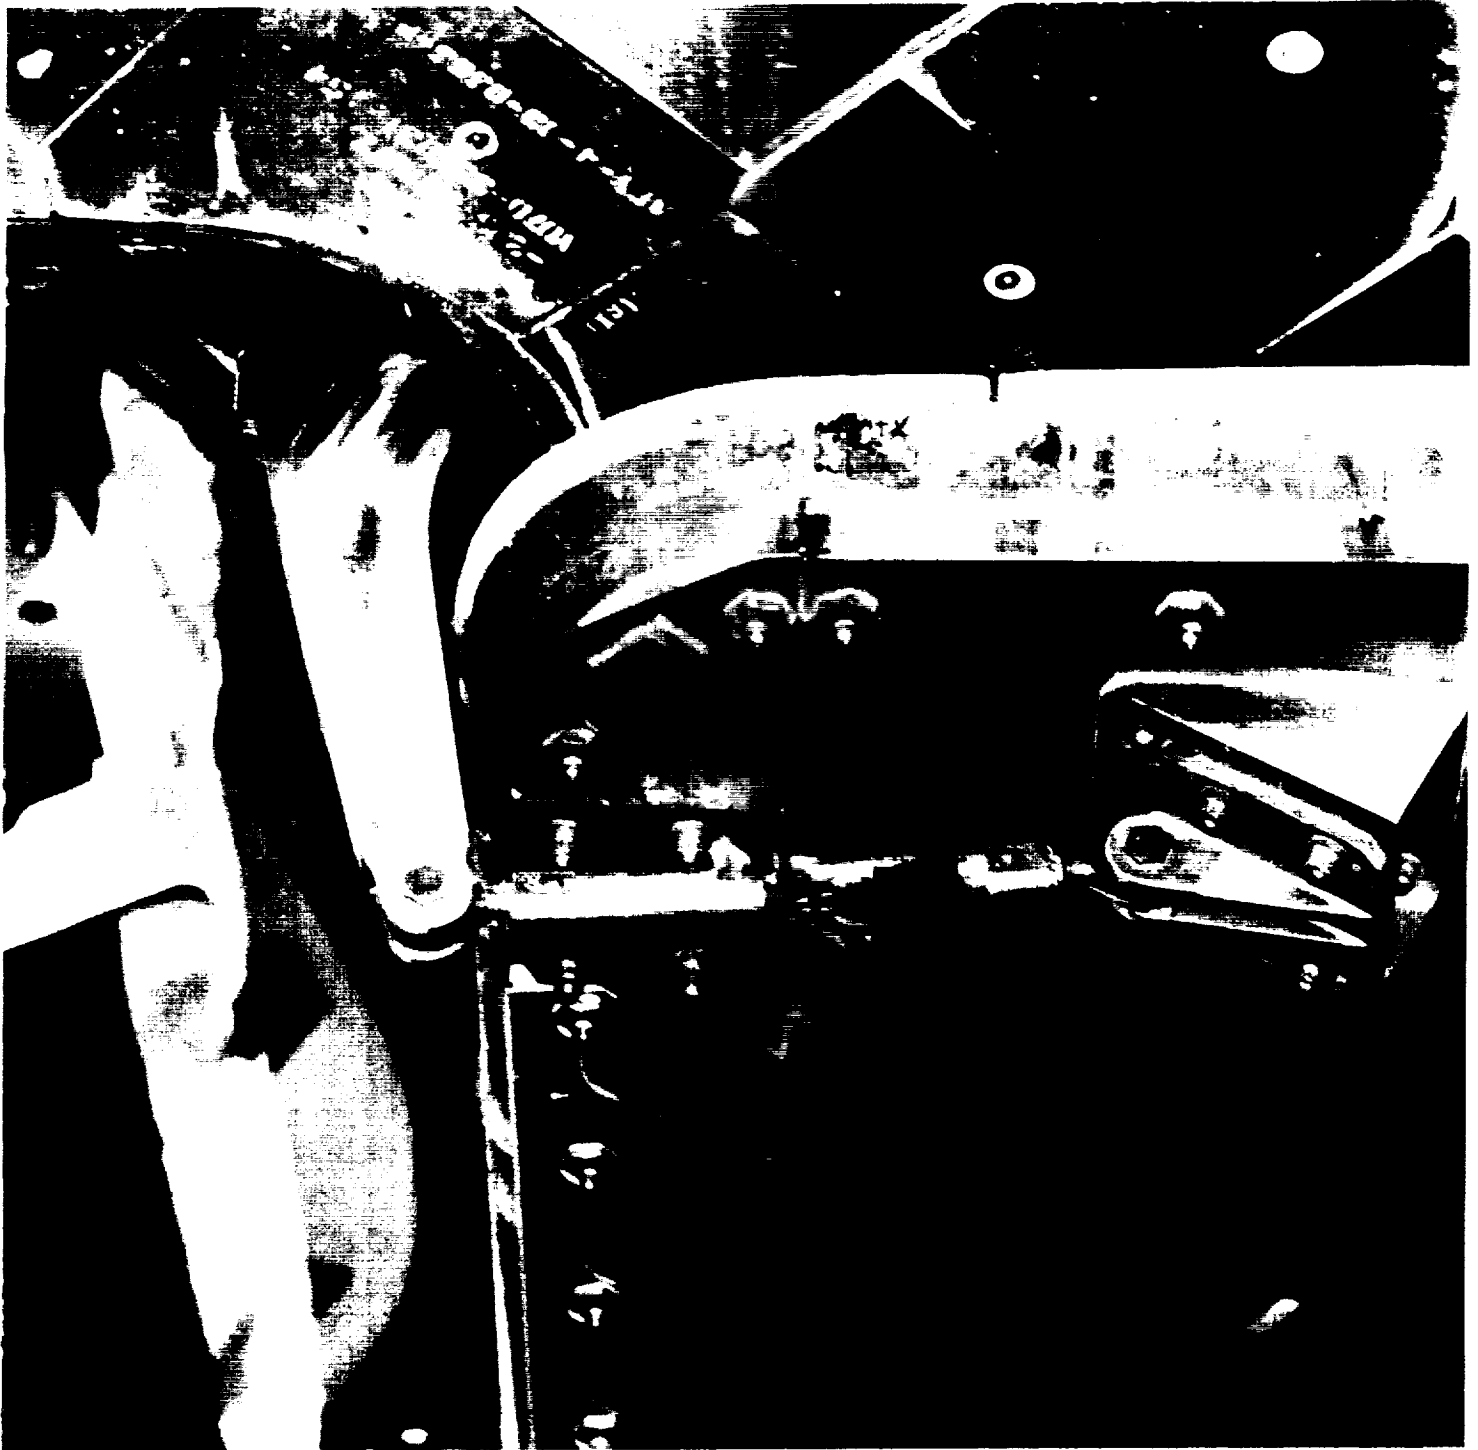
ET/ORB umbilical purge barrier (baggie) was attached to the ET door struts outside of the umbilical cavity and may have contributed to the tile damage aft of that location.

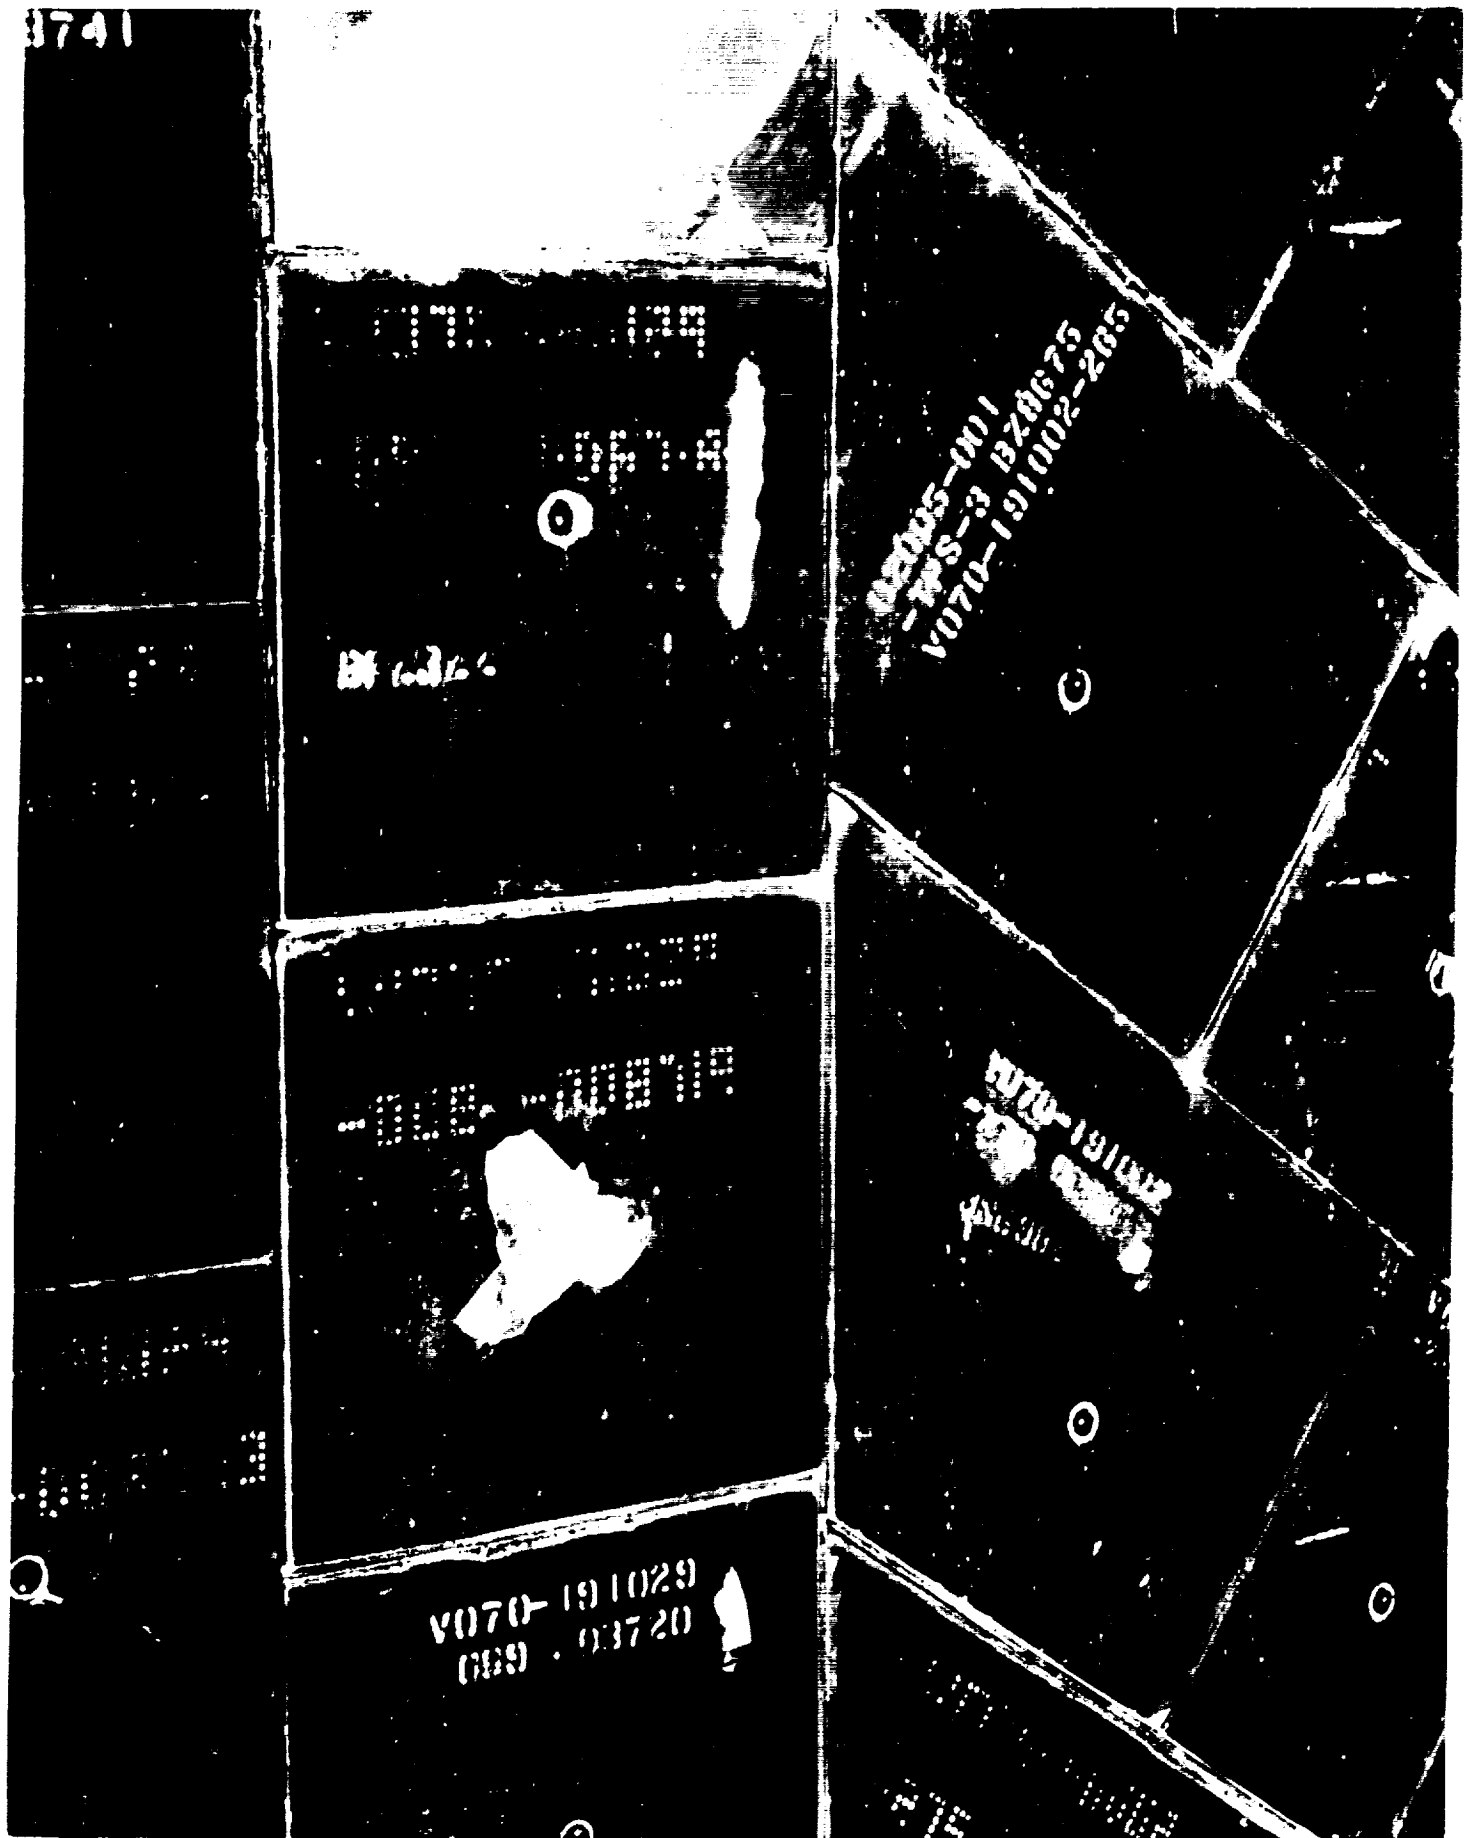
Typical tile damage from debris impacts

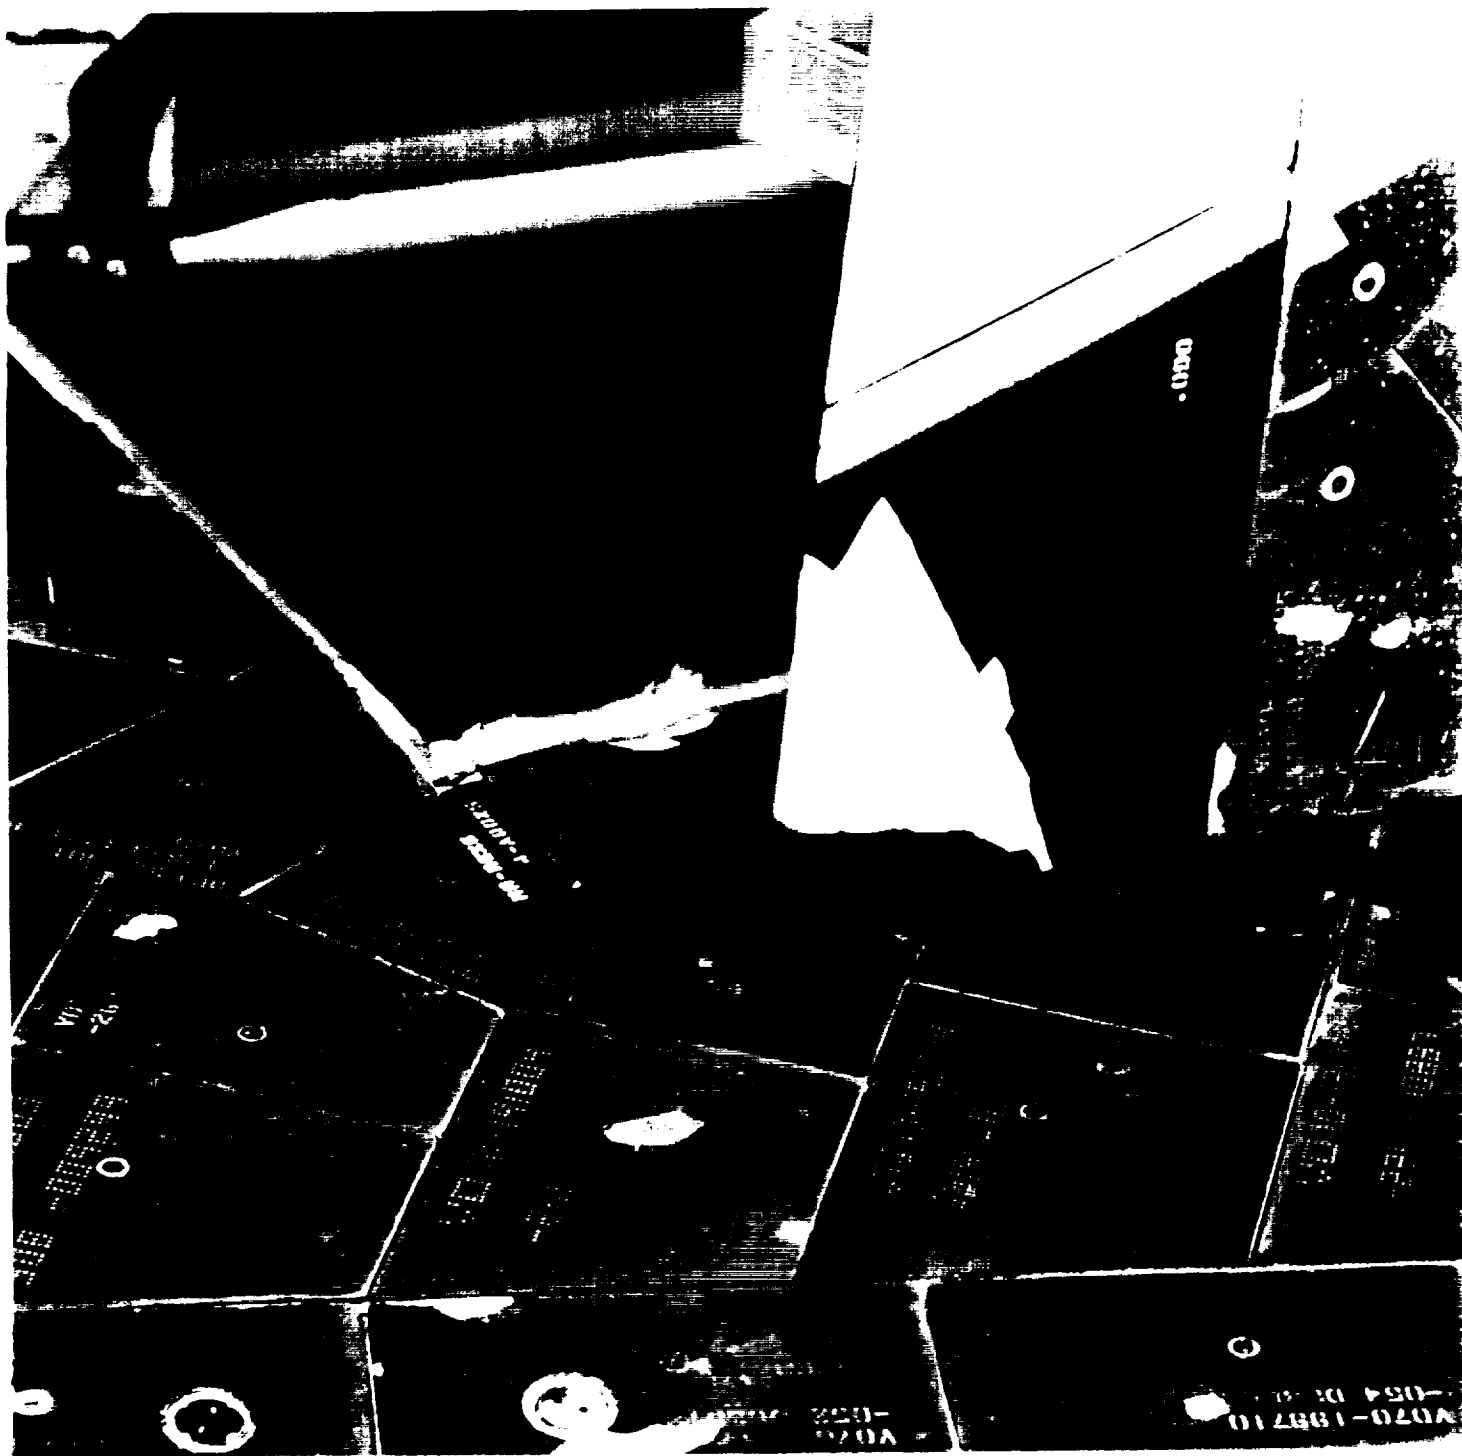
Damage to corner tile on the RH MLG door occurred when the
door was opened for landing
